## Case Study on Debugging of DDGEN Generated Device Driver Code

Someshwar D, Pavitra M, Sandeep P.  
{someshward, pavitra, sandeep}@vayavyalabs.com  
Vayavya Labs, Belgaum India

This paper describes our experience in debugging of DDGEN generated device driver code. DDGEN generates device driver code in C from a high-level device specification (DPS) and the corresponding software architecture specification (RTS) as input. Unlike the usual development methodologies where debugging is typically performed at the same level as the input specification<sup>1</sup>, in DDGEN based methodology, we debug the generated C code and not the DPS or RTS. Fixing of the bug mostly involves modifying the input specification (DPS or RTS). Our case study consisting of specific examples of debugging as well as the debugging guidelines presented in this paper will ensure that a DDGEN user can efficiently as well as effectively debug generated C code and further map the fix back to DPS or RTS.

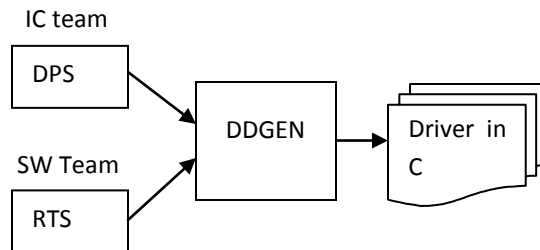
As shown in the above figure, DDGEN requires two input specifications viz. DPS and RTS. DPS (Device Programming Specification [2]) captures all relevant aspects (registers, interrupts, fifos, programming sequence etc.) of a given device. Thus DPS is a formal specification language. RTS (Run Time Specification [2]) captures software considerations like the target operating system, driver model, interrupt handling mechanism etc. DDGEN compiles both the input specifications and automatically synthesizes the device drivers. Refer [1] for a complete discussion on DDGEN.
